Manhole Inspection Summary

Manhole # S21K__002MH

Insp Date: **4/2/08 3:14 PM**

Location Address: **1847 wilhelm-mchenry alley**

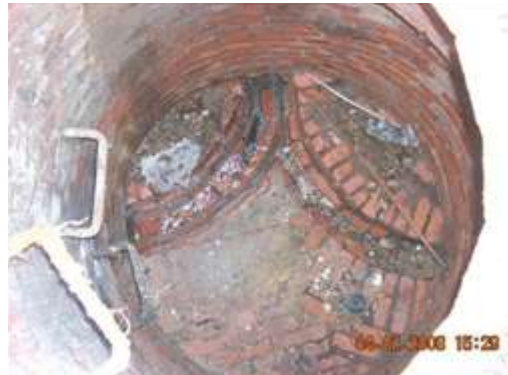
Frame Offset: **2** (in.) Condition: ☒ Sound ☐ Cracked ☐ Leaks

frame offset

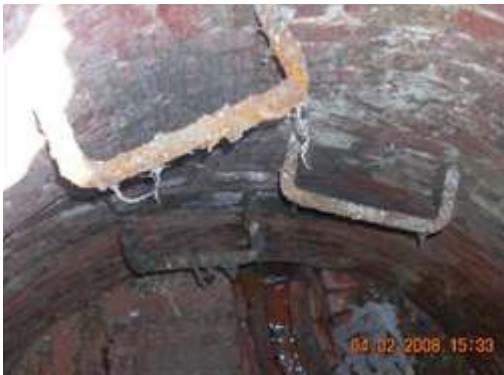
Defect 3

bench debris

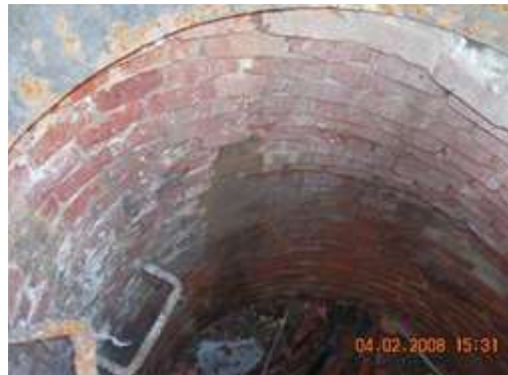
Defect 2

Steps Count: **3** Missing: **0** ☒ Corroded

corroded steps

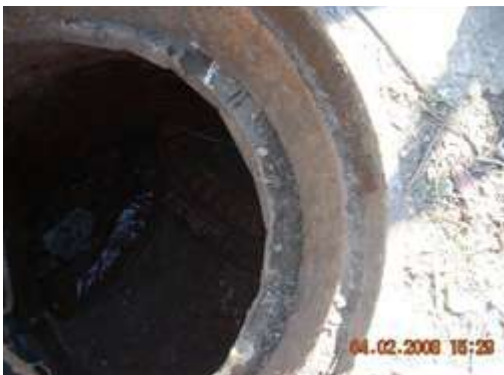
Defect 1

Infiltration: ☐ None ☐ Joint ☐ Cracks ☐ Mortar ☐ Roots ☒ Wall

infiltration @ corbel wall

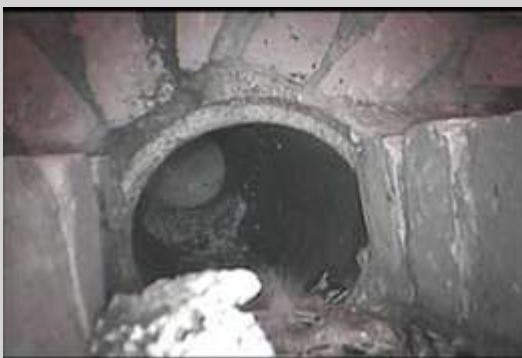
4 O'Clock Inflow

Pipe Height: **0** (in.)
Pipe Material: ☐ Pipe Lined
Invert Depth: **0.00** (ft.) Flow Characteristics: **None**
Deposits: ☐ None ☐ Mud ☐ Sludge ☒ **Debris** ☐ Grease
Silt Depth: **2** (in.) Deposits Extent: **Light**
Infiltration: **None** Pipe Seal Cond: **Sound**

Connects To: **Stub connection / abandoned**
